Pedestrian Road Safety Audit MD 355 (Wisconsin Avenue)

MD 410 (Montgomery Avenue) to Leland Street
Montgomery County, Maryland

June 2011

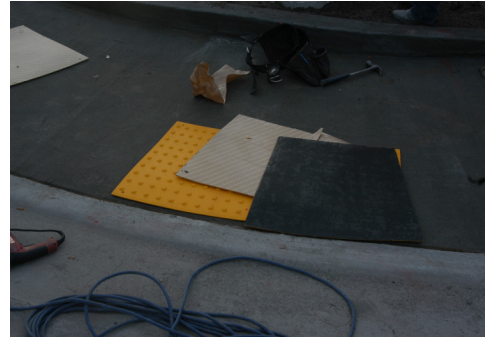
Truncated domes can be retrofitted easily on existing curb ramps

- **ADA Compliance:** ADA-compliance issues in the corridor include non-compliant curb ramp slopes, curb cut locations and crosswalk alignments, and missing truncated domes (i.e., detectable warning surfaces). Steep curb ramps make maneuvering the ramp difficult for pedestrians with mobility limitations, while curb ramps that are not aligned with crosswalks may misdirect pedestrians with visibility impairments into inappropriate areas. Truncated domes provide positive guidance to pedestrians with visibility impairments as they approach a crossing location. These issues may be addressed by updating curb ramps and sidewalks to comply with current ADA regulations.

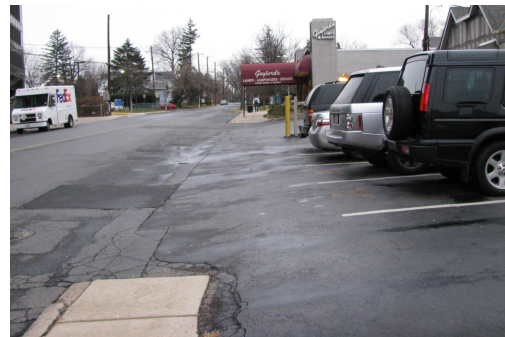
Accessibility issue at a missing sidewalk south of Leland Street.

- *Limited Sidewalk Accessibility:* The PRSA team noted a couple of locations along side streets where sidewalk conditions present accessibility difficulties or limit continuity and walkability within downtown Bethesda. Gaps or narrow widths along some sidewalks could be addressed through future planning efforts, community development, or Policy Area Mobility Review (PAMR) improvements.
